# TECHNICAL NOTE

Bureau of Land Management U.S. DEPARTMENT OF THE INTERIOR

OBSERVATIONS OF OVERLAND FLOW ON A  
TREATED AND UNTREATED JUNIPER AREA

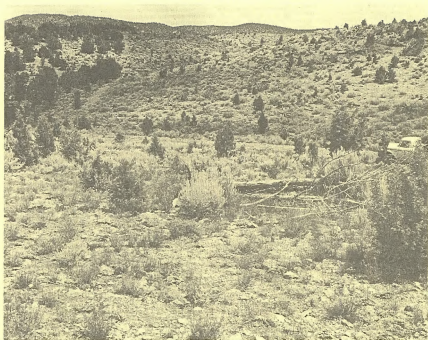
Figure 1. Area on right chained one way 1957; area on left original juniper, sagebrush cover.

Ground Cover. Table I gives an indication of the ground cover on the two plots and figures 1 through 10 give a visual observation of the treated plot and figures 11 through 13 of the non-treated plots.

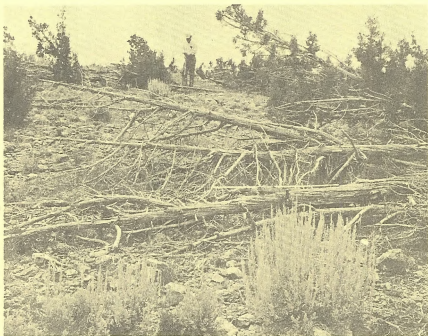
Figure 2.

The drainage reach started thirty feet behind Jim Brunner (Fig. 2).

Sheet erosion and overland flow were not identifiable in the first twenty-one feet of the drainage the day after an .8" storm.

From 21' to 66' (Juniper obstruction) (Fig. 2), the overland flow sheet and rill erosion was clearly identifiable. (Fig. 3 and 4).

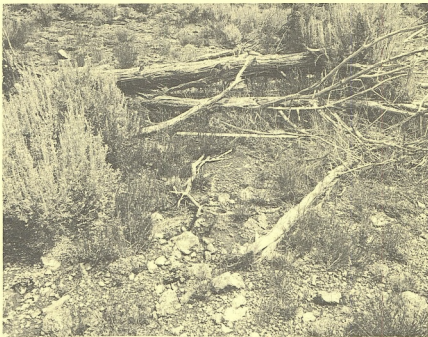
Figure 5.

Sediment was deposited against the grass-litter check dam (Fig. 5) for a distance of three feet (Fig. 6). The chained juniper had for the past twelve years provided a micro environment that allowed accumulation of soil, establishment of introduced and native grasses and shrubs in addition to providing an effective check dam and infiltration field that prevented loss of soil on site and stopped overland flow 100%. (Fig. 7).

The ground was dry and hard, about normal for July in southeastern Nevada. The rainstorm lasted for fifteen minutes and measured 0.85 inches. Moisture penetration immediately following the storm was 3.75" in the open erosion pavement area (Fig. 9) and 5.0" adjacent to a desert wheatgrass plant (Fig. 5), both in the treated area. In the untreated area the moisture penetrated 3.0" in the open erosion pavement area and 9.0" under the juniper duff. The next day following the storm the moisture had drained by gravity to a depth of 18" to 20" with the top 1 to 3 inches of the soil profile almost dry.

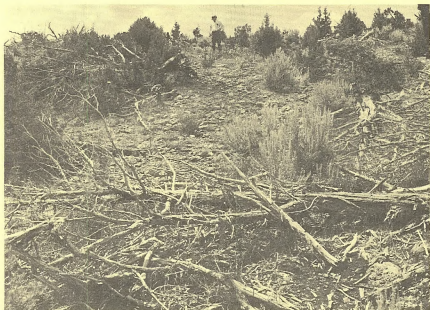
Figure 8.

The drainage reach started 175' behind Jim Brunner (Fig. 8).

Overland flow and sheet erosion was barely identifiable for the first 115 feet. The next 60 feet sustained slight sheet erosion followed by an additional 50 feet of moderate to severe sheet erosion.

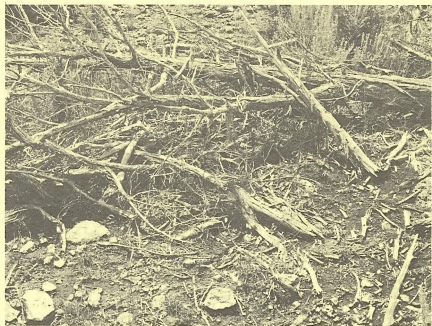
Figure 10.

At 225 feet a juniper litter obstruction diverted the water at a  $25^{\circ}$  angle, but was unable to reduce the velocity sufficiently to prevent the water and sediments from penetrating the debris and continuing its erosive action. Rill erosion was evident immediately downstream

from the obstruction which included juniper litter, crested wheat and squirreltail grasses. (Fig. 10). The water and sediment continued another 300 feet until the sediment was deposited in a recently cleaned access road ditch and the water continued down the ditch and crossed the road and into the main drainage channel.

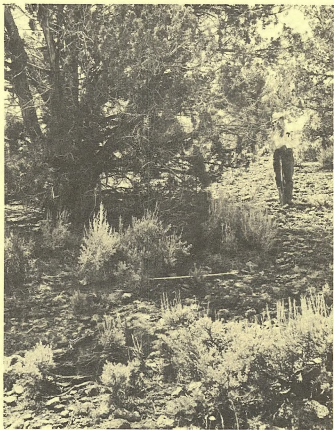
Figure 11.

The drainage reach started 165' behind Jim Brunner (Fig. 11).

Velocity and volume of the overland flow was sufficient to cut through two to four inches deep of juniper duff that had been in place many years (estimate 6 years). The water flow was diverted by the juniper duff, the smallest volume going along the left side of Fig. 11 causing very little erosion. The majority of the volume was directed along the right side of Fig. 11 causing rill and gully erosion. (Fig. 12 and 13).

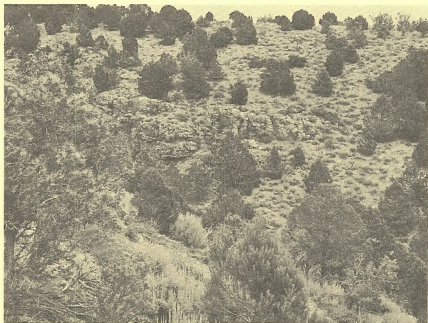
Figure 14.

The soils and ground cover were subjected to the same intensity storms as shown in the treated and untreated areas described in A, B and C. The slopes exceeded 55% (Fig. 14) and ground cover was approximately the same as the chained areas.

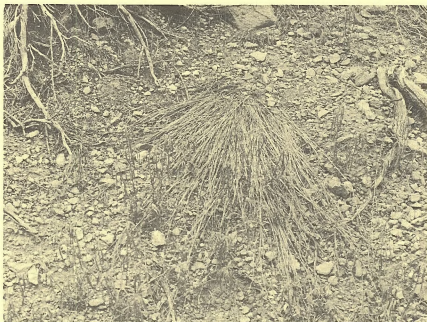
Figure 15.

Active erosion on these steep slopes consisted of slight gravity and wind erosion (Fig. 15). Litter was accumulating in place.

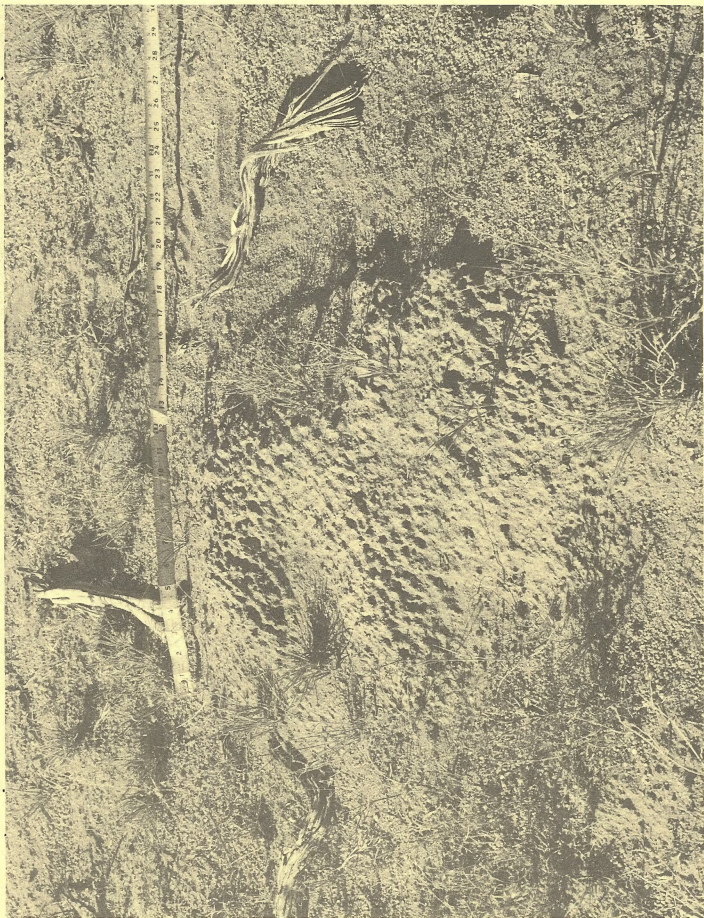
Figure 17.

The effects of sheet flow and rainfall splash erosion can be seen in Figure 17 and 18 respectively. As sheet erosion occurs around the base of the plants, the plants become weaker due to an induced droughty condition. As the plant weakens and portions of it die, the soil becomes exposed and subject to splash and sheet erosion which in turn accelerates the erosion processes.

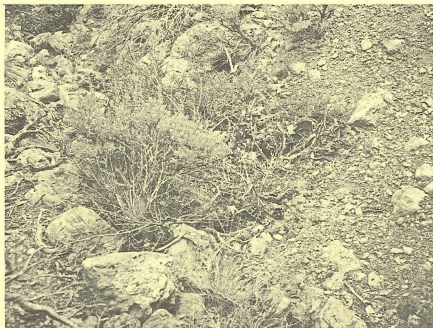
Figure 18.

The drainage channels showed no signs of any overland flow for many years (Fig. 18), estimated at 10 years. Old litter, decaying oak leaves and mature plants indicated the channel had been stable for a considerable length of time.
